Asataranga Nodal school Astaranga Puri

1. About the Building

Audit Report

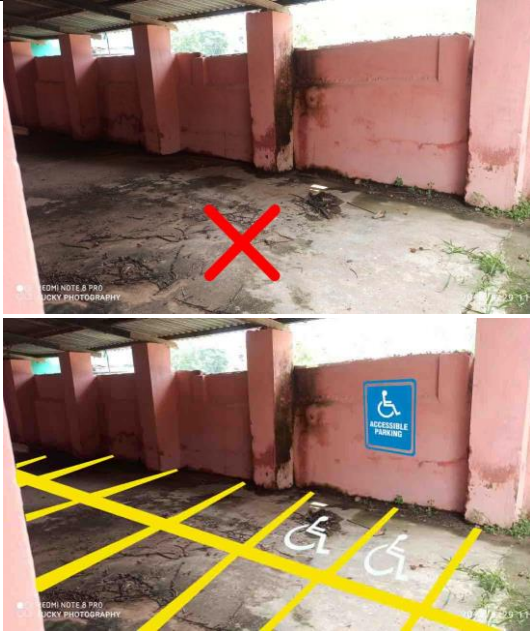
Issues Observed	Photograph	Recommendation	Technical Recommendation
<ol style="list-style-type: none"> 1. An inaccessible space for parking near the back gate. 2. Vehicles parked on roadside.

<ol style="list-style-type: none"> 1. A Parking bay to be construct in the right side of building. 2. Accessible parking (3600 x 6000) area to be demarcated in right side of building. 3. Good location of parking area. 4. A signage of 200mm x 200mm, suggested colour contrasts is white-blue, yellow-red, or white-red. 5. Accessible pathway with tactile flooring from parking to main building entrance 6. Illumination of 100 lx. 	<p>SI# 1 Parking Examples of Best Practises</p>

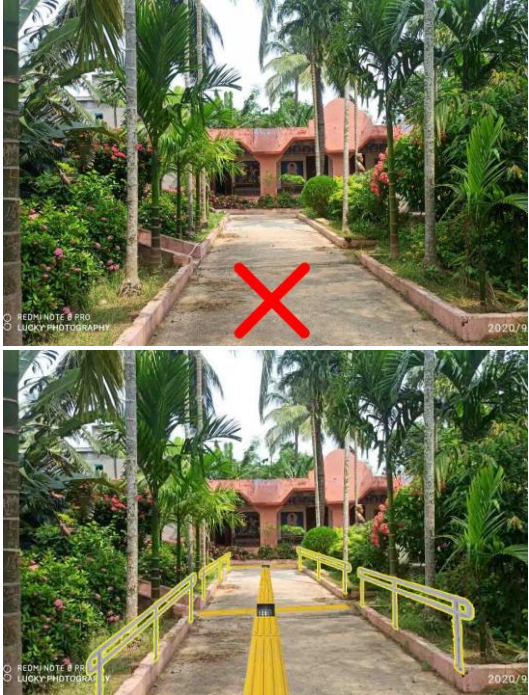
Issues Observed	Photograph	Recommendation	Technical Recommendation
<ol style="list-style-type: none"> 1. Inaccessible route from main gate Entrance to classroom entrance. 2. No tactile guiding tile 3. No Handrail on path way 4. Pathway Width 4236 mm

<ol style="list-style-type: none"> 2. Accessible pathway. Preferably to be covered and made non slippery. 3. Tactile guiding tiles including directional, hazard warning and positional tiles. 4. Accessible directional signage. 5. Accessible handrail on both sides of path. 	<p>SI# 3 Accessible Route Examples of Best Practises</p>

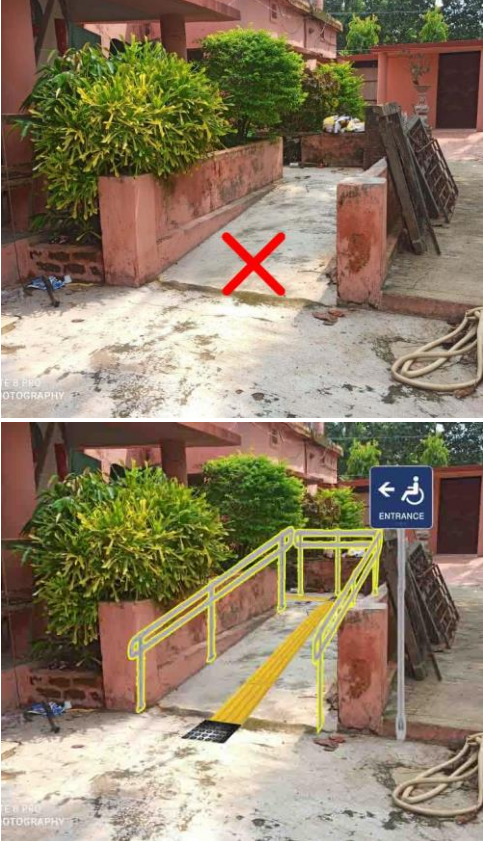
Issues Observed	Photograph	Recommendation	Technical Recommendation
<ol style="list-style-type: none"> 1. Landing space is 1500 mm X 1500 mm. 2. Inaccessible Concrete handrail in ramp 3. No Signage near entrance 4. No difference in floor finish. 5. No signage 6. Inaccessible ram available in entrance

<ol style="list-style-type: none"> 1. Accessible ramp to be reconstruct at the entrance left of faculty block with 1:12 gradient, accessible handrail and tactile tiles. 2. Accessible ramp to be construct in all building entrance 3. Floor finish to be distinguished (suggestion – thin rubber mat). 4. Door mat should avoid. 5. Illumination of 150 lux 	<p>SI# 4 Accessible Entrance Examples of Best Practises</p>

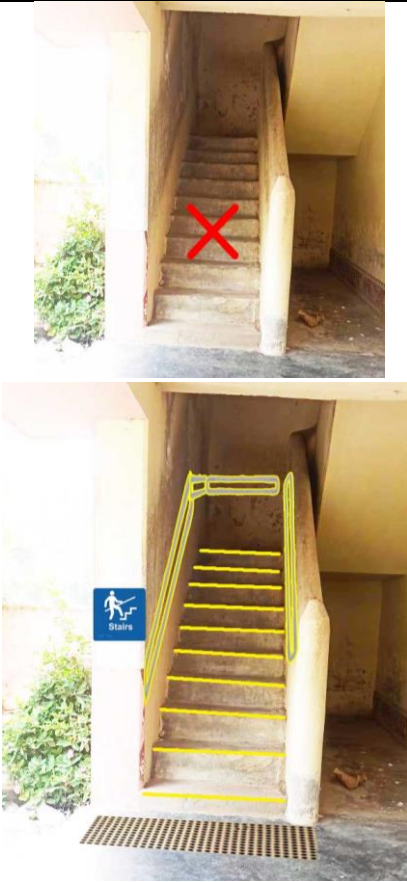
Issues Observed	Photograph	Recommendation	Technical Recommendation
<ol style="list-style-type: none"> 1. Step risers 190mm high and thread 190 mm. 2. No Handrail 3. Inadequate illumination on the stairs. 4. Surface of the steps non-slippery and non-glary. 5. Steps are not uniform in width and height. 6. Stair width is 304mm.

<ol style="list-style-type: none"> 1. Step risers to be 150 mm high and tread 300mm wide. 2. 300mm wide. 3. Colour contrasting strip at the edge of the steps. 4. Two handrails in both side of stairs at heights of 900mm and 760 mm. 5. Warning tiles at the beginning and end of each flight at 300mm 6. Under-stair area to cordoned off to avoid accidents. 7. Steps with no nose. 	<p data-bbox="1697 389 1995 475">SI# 6 Stairs Examples of Best Practises</p>

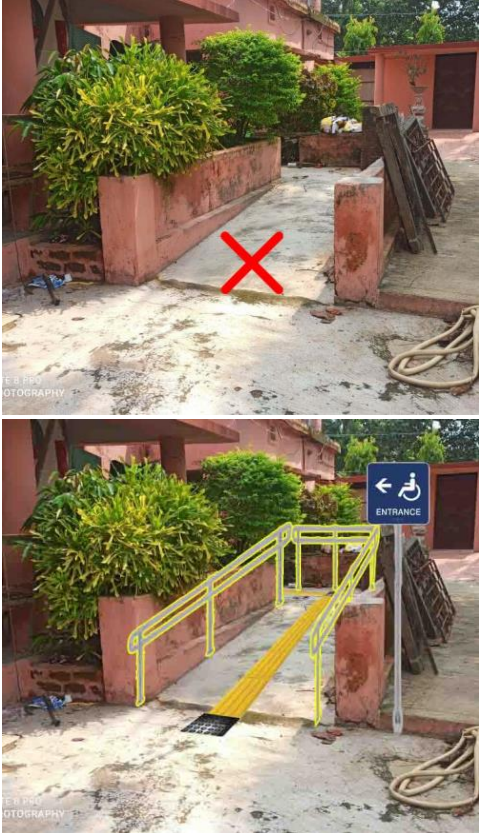
Issues Observed	Photograph	Recommendation	Technical Recommendation
<ol style="list-style-type: none"> 1. Inaccessible Ramp near entrance. 2. Ramp Width 1524mm 3. Ramp Length 3352mm 4. Ramp height 304mm 5. No guiding tile 6. Inaccessible Concrete handrail in ramp

<ol style="list-style-type: none"> 1. Accessible ramp to be reconstructed at the entrance left of faculty block with 1:12 gradient, accessible handrail and tactile tiles. 2. Accessible ramp to be construct in all building entrance 3. Floor finish to be distinguished (suggestion - thin rubber mat). 4. Door mat should avoid. 5. illumination of 150 lux 	<p>SI# 4 Accessible Entrance Examples of Best Practises</p>

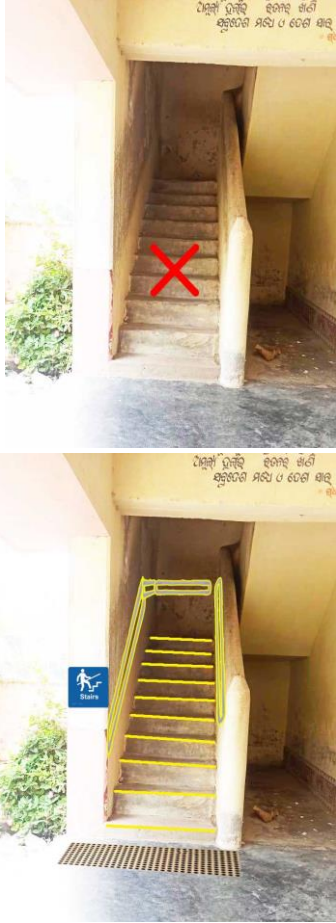
Issues Observed	Photograph	Recommendation	Technical Recommendation
<p>1. No Handrail.</p>

<ol style="list-style-type: none"> 1. Handrails to be installed at both sides with two grip heights of 900mm and 760mm 2. Handrails to be circular have smooth surface and are non-slippery. 3. Adequate hand clearance between the wall and the handrail of 50 mm or more. 4. Handrails to be maintained and kept free from dust. 	<p>Sl# 8 Handrails Examples of Best Practises</p>

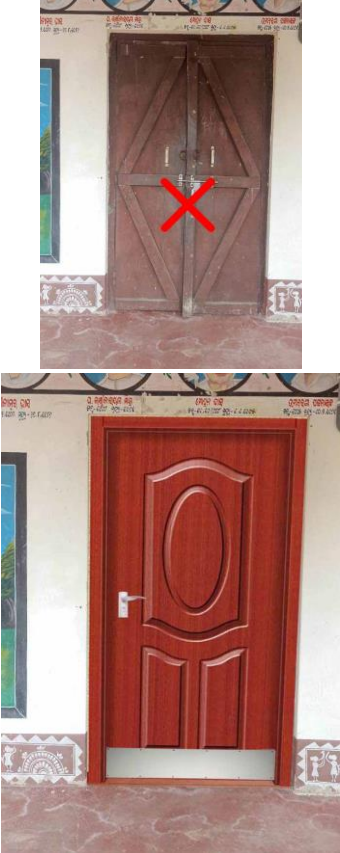
Issues Observed	Photograph	Recommendation	Technical Recommendation
<ol style="list-style-type: none"> 1. Easily opened. 2. Handles with 1158 mm height 3. Door lock at 1055 mm. 4. No color contrast between door and wall. 5. No kick plate on the door. 6. Door Width 914 mm.

<ol style="list-style-type: none"> 1. Suggested color contrast between door, door frame, wall and floor – blue-white, blue-yellow, red-white the accessible toilet door 2. Thresholds and doormats to be removed. 	<p>SI# 12 Door and Doorways Examples of Best Practises</p>

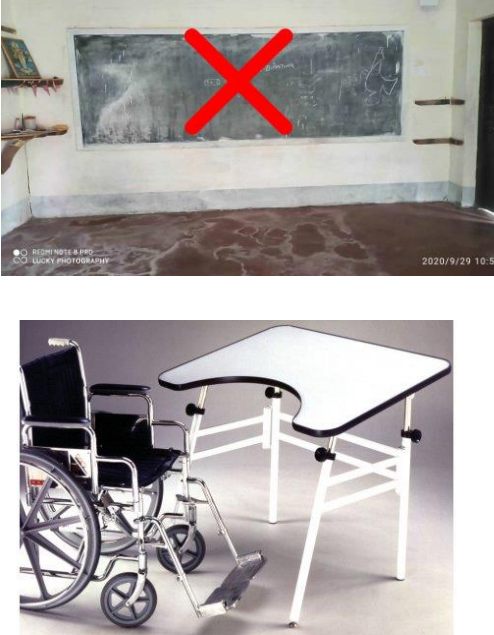
Issues Observed	Photograph	Recommendation	Technical Recommendation
<ol style="list-style-type: none"> 1. Inaccessible furniture and blackboard in classrooms. 2. Blackboard height 762 mm

<ol style="list-style-type: none"> 1. 900 mm height, 900mm wide and 1200mm deep clear space in front of the book issue counter 2. should have adequate space for the wheelchair of 1500mm in the reading room 3. There should be a gap of 1200mm between book shelves. 4. Jaws software to be install in at list 5 computers. 5. There should be audio books and braille books. 6. Black board height should be in 900 mm to 1200 mm 7. There should be proper illumination of 250 lux in class room. 8. There should be 1200 mm space to move the wheel chair in the classroom. 9. Teacher should be trained to teach student with disability. 	<p data-bbox="1713 327 1982 406">Sl# 14 Cafeteria Examples of Best Practises</p>

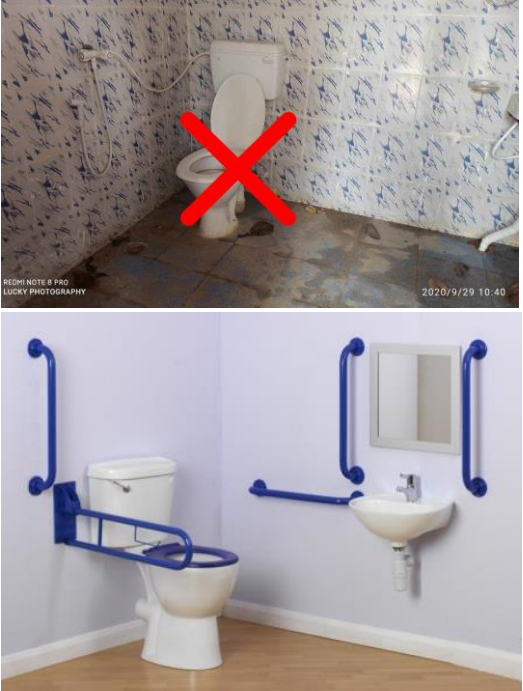
Issues Observed	Photograph	Recommendation	Technical Recommendation
<ol style="list-style-type: none"> 1. Pathway towards toilet and inaccessible. 2. 8 toilets in school 3. Toilet door width is 944mm. 4. One toilet have Indian commode style pan. 5. No lighting. 6. There is a color contrast between the floor, wall and sanitary fittings 7. No water. 8. Inaccessible Ramp Available in front of toilet 9. Cubicle size is 2316x 2316mm 10. Basin height 792 mm, Depth 304mm 11. No colour contrast 12. Bad illumination. 13. No grab bars. 14. No Signage

<ol style="list-style-type: none"> 1. Toilet door to open outwards, be double hinged or sliding type. 2. WC to be installed in a corner with centre line of the WC at a distance of 450mm to 500mm from the adjacent wall. The front edge of WC to project 750mm of/from the rear wall. 3. Seat height 450mm. 4. Horizontal grab bar to be installed on adjacent wall at a height of 200mm from the WC seat. 5. A fold up grab bar to be installed at a centreline distance of 320mm-200mm from the WC seat. 6. Wash basin to be installed at a distance of at least 400mm from the side wall. 7. Top-edge of the wash basin at a height between 800mm and 840mm from the floor level. 8. Clear knee space of at least 750mm height x 750mm 	<p data-bbox="1711 472 1980 547">SI# 13 Accessible Toilet Examples of Best Practises</p>

width x 200mm depth under the wash basin, with additional toe-space of 300mm height x 750mm width x 230mm depth.	
		9. Mirror to be at accessible height of 850 mm.

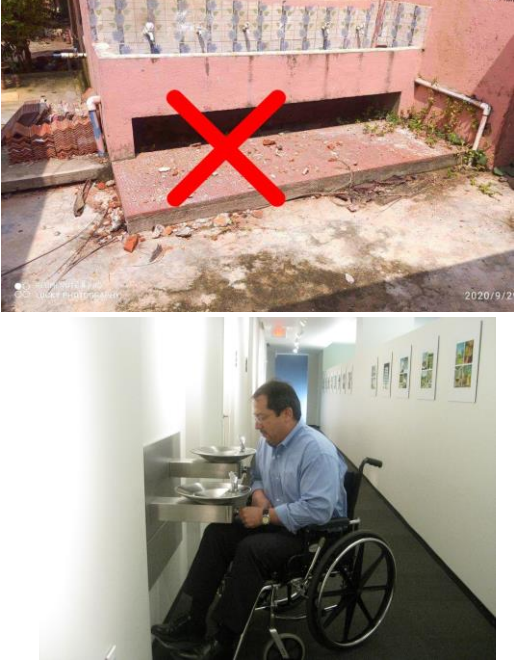
Issues Observed	Photograph	Recommendation	Technical Recommendation
<ol style="list-style-type: none"> 1. Approach to drinking water not accessible. 2. Wash basin height 640mm 3. They are drinking water from wash basin 4. Threshold Available Height 100mm 5. Class Room to Drinking water point Inaccessible 6. 2 Drinking Water point Available

<ol style="list-style-type: none"> 1. To be Establish a water filter 2. Height of water filters to be lowered (not higher than 1200 mm). 3. Clear knee space of at least 750mm height x 750mm width x 200mm depth under the wash basin, with additional toe-space of 300mm height x 750mm width x 230mm depth 4. Drinking glass and cups required. 	<p>SI# 15 Drinking Water Facility Examples of Best Practises</p>

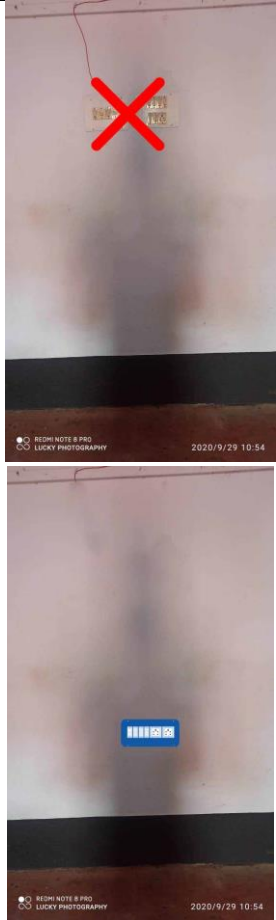
Issues Observed	Photograph	Recommendation	Technical Recommendation
<ol style="list-style-type: none"> 1. Switch board height 1252 mm. 2. No colour contrast between switch board and wall.

<ol style="list-style-type: none"> 1. Switch board to be reinstalled at height of 900 - 1200mm and not below 400mm. Clear space from the corner of 400mm. 2. Information on controls and switches in Braille. 	<p>SI# 16 Control and Operating Mechanisms Examples of Best Practises</p>

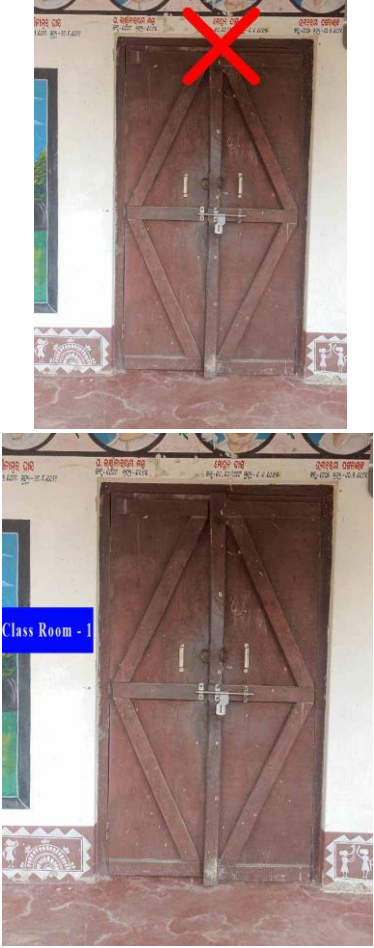
Issues Observed	Photographs	Recommendation	Technical Recommendation
<p>1. Inaccessible Signage Available</p> <p>2. Signage Height 2438mm</p>

<p>1. Prominent visible signage using the international symbol of accessibility, identifying/advertising/signifying accessible entrance and exit, reserved car parking, presence of toilets for persons with disabilities and availability of special services.</p> <p>2. Signage size not less than 60 mm for doors, 110 mm for corridors and 200 mm for external use.</p> <p>In the facility to be provided with Braille and Tactile supplements.</p> <ol style="list-style-type: none"> Wherever possible, audio signage to be provided along with Braille and Tactile. All Braille and tactile signage to be placed at the height of 900-1500mm, with ideal location at 1050 mm above the finished floor level. Signage to be placed/mounted on the wall alongside the door. 	<p>Sl# 17 Signage Examples of Best Practises</p>

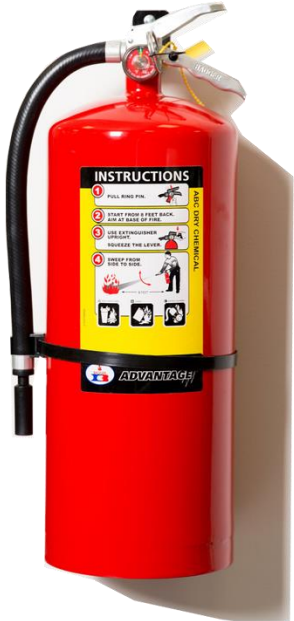
Issues Observed	Photographs	Recommendation	Technical Recommendation
<ol style="list-style-type: none"> 1. No exit door. 2. No emergency evacuation provision. 3. No fire Extinguishers in school.

<ol style="list-style-type: none"> 1. Evacuation route plan to be developed and displayed in different locations of each floor and 2. From safety point of view classrooms of students / teachers with disabilities at ground floor. Classrooms to be made mobile so that as the child with disability would progress from one class to the other, that classroom would be run in ground floor. 3. Staff to be trained to assist persons with disabilities during evacuation. 4. Install fire extinguisher in every floor. 	<p>SI# 18 Emergency Evacuation Examples of Best Practises</p>
