# Puri Zila School Puri

## 1. About the Building

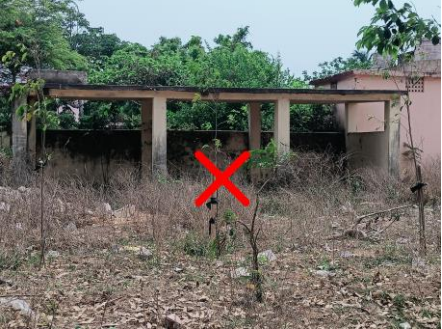
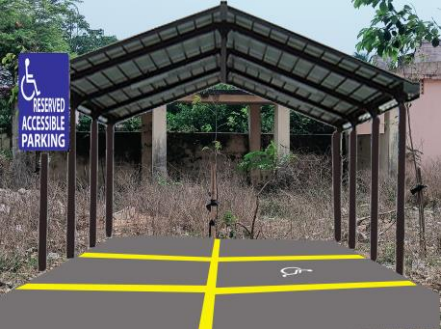
### 1. Parking

Issues Observed	Photograph	Recommendation	Technical Recommendation
<ol style="list-style-type: none"> <li>1. An inaccessible space damaged for parking the backside.</li> <li>2. Vehicles and student cycle parked on pathway side and garden area.</li> </ol>

<ol style="list-style-type: none"> <li>1. A Parking bay to be construct in the right side of building.</li> <li>2. Accessible parking (3600 x 6000) area to be demarcated in right side of building.</li> <li>3. Good location of parking area.</li> <li>4. A signage of 200mm x 200mm, suggested colour contrasts is white-blue, yellow-red, or white red.</li> <li>5. Accessible pathway with tactile flooring from parking to main building entrance</li> <li>6. Illumination of 100 lx.</li> </ol>	<p><b>SI# 1</b> <b>Parking</b> <b>Examples of Best Practises</b></p>

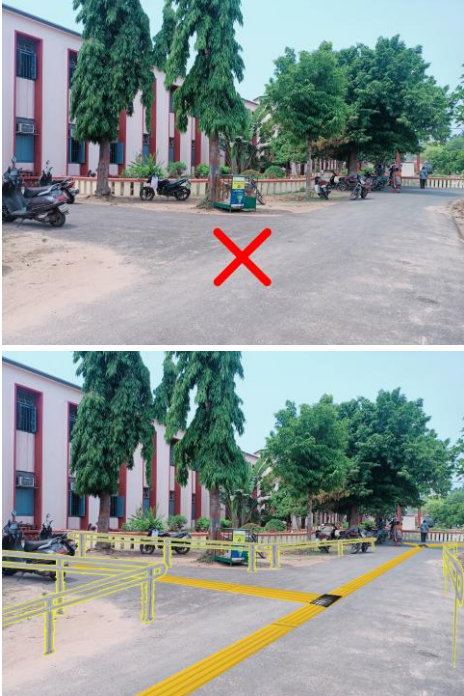
## 3. Accessible route

Issues Observed	Photograph	Recommendation	Technical Recommendation
<ol style="list-style-type: none"> <li>1. Inaccessible route from main gate Entrance to classroom entrance.</li> <li>2. No tactile guiding tile</li> <li>3. No Handrail on pathway</li> <li>4. Pathway Width 5236 mm</li> </ol>

<ol style="list-style-type: none"> <li>2. Accessible pathway. Preferably to be covered and made non slippery.</li> <li>3. Tactile guiding tiles including directional, hazard warning and positional tiles.</li> <li>4. Accessible directional signage.</li> <li>5. Accessible handrail on both sides of path.</li> </ol>	<p><b>SI# 3</b> <b>Accessible Route</b> Examples of Best Practises</p>

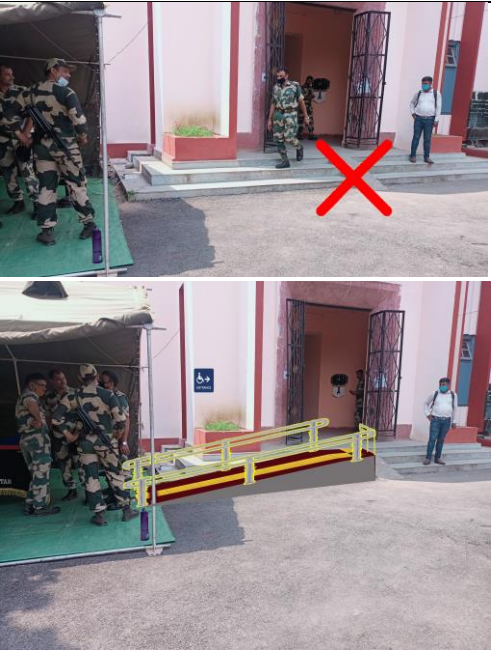
### 4. Entrance

Issues Observed	Photograph	Recommendation	Technical Recommendation
<ol style="list-style-type: none"> <li>1. Two Inaccessible Ramp available. One is third entrance of school and another is Infront of conference hall building.</li> <li>2. Inaccessible iron handrail in ramp</li> <li>3. No Signage near entrance</li> <li>4. No difference in floor finish.</li> <li>5. Main building entrance height 518mm and conference hall entrance height 300mm</li> </ol>

<ol style="list-style-type: none"> <li>1. Accessible ramp to be reconstruct at the entrance left of faculty block with 1:12 gradient, accessible handrail and tactile tiles.</li> <li>2. Accessible ramp to be construct in all building entrance</li> <li>3. Floor finish to be distinguished (suggestion – thin rubber mat).</li> <li>4. Door mat should avoid.</li> <li>5. Illumination of 150 lux</li> </ol>	<p><b>SI# 4</b> <b>Accessible Entrance</b> <b>Examples of Best Practises</b></p>

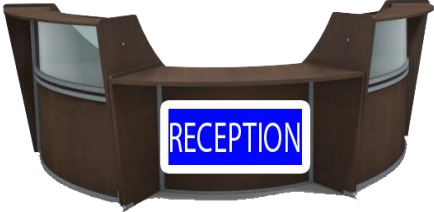
## 5. Reception and lobby

Issues Observed	Photograph	Recommendation	Technical Recommendation
<p>1. No reception and lobby.</p>

<ol style="list-style-type: none"> <li>1. Receptions counter to be establish near entrance.</li> <li>2. 900mm wide and 1200mm deep clear space in front of the reception counter.</li> <li>3. Non-reflective counter surface</li> <li>4. Counter height between 760 mm to</li> <li>5. 800mm from the floor with a 400mm to 600mm clear recess under the counter.</li> <li>6. Accessible identification signage near reception counter with odiya , English Language.</li> <li>7. Guide map of building adjacent to reception.</li> <li>8. Accessible directional signage directing to various building facilities at the reception</li> </ol>	<p><b>SI# 5</b> <b>Reception and Lobby</b> <b>Examples of Best Practises</b></p>

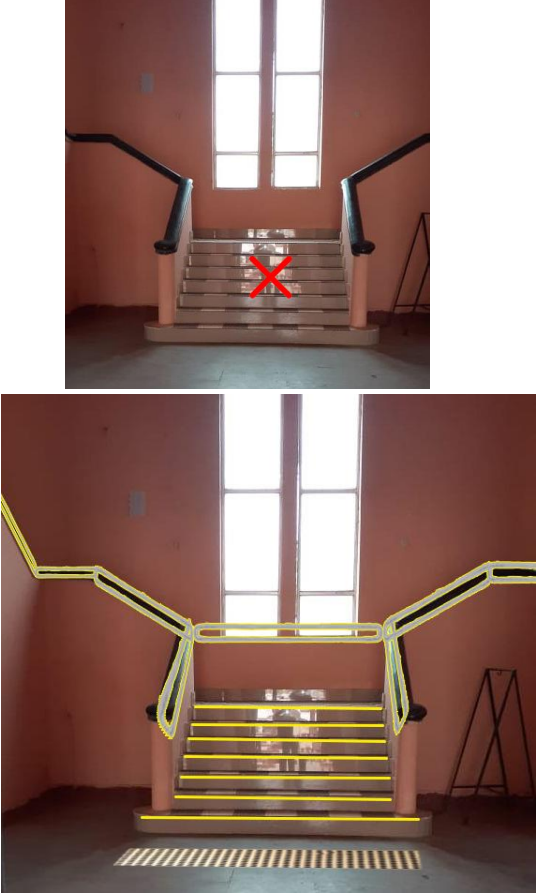
## 6. Stairs

Issues Observed	Photograph	Recommendation	Technical Recommendation
<ol style="list-style-type: none"> <li>1. Step risers 170mm high and tread 170 mm.</li> <li>2. Both side concrete Handrail</li> <li>3. Inadequate illumination on the stairs.</li> <li>4. Surface of the steps non-slippery and non-glary.</li> <li>5. Steps are not uniform in width and height.</li> <li>6. Stair width is 1862 mm.</li> </ol>

<ol style="list-style-type: none"> <li>1. Step risers to be 150 mm high and tread.</li> <li>2. 300mm wide.</li> <li>3. Colour contrasting strip at the edge of the steps.</li> <li>4. Two handrails in both side of stairs at heights of 900mm and 760 mm.</li> <li>5. Warning tiles at the beginning and end of each flight at 300mm</li> <li>6. Under-stair area to cordoned off to avoid accidents.</li> <li>7. Steps with no nose.</li> </ol>	<p><b>SI# 6 Stairs</b> Examples of Best Practises</p>

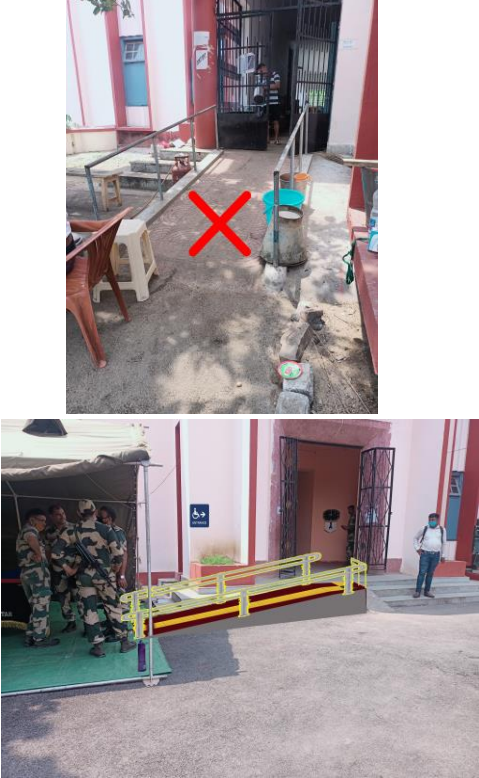
## 7. Ramp

Issues Observed	Photograph	Recommendation	Technical Recommendation
<ol style="list-style-type: none"> <li>1. Two Inaccessible Ramp available. One is third entrance of school and another is Infront of conference hall building.</li> <li>2. Ramp Width 1524mm</li> <li>3. Ramp Length 1260mm</li> <li>4. Ramp height 518 mm</li> <li>5. No guiding tile.</li> <li>6. Inaccessible iron handrail in ramp</li> </ol>

<ol style="list-style-type: none"> <li>1. Accessible ramp to be reconstructed at the entrance left of faculty block with 1:12 gradient, accessible handrail and tactile tiles.</li> <li>2. Accessible ramp to be construct in all building entrance.</li> <li>3. Floor finish to be distinguished (suggestion - thin rubber mat).</li> <li>4. Door mat should avoid.</li> <li>5. illumination of 150 lux</li> </ol>	<p><b>Sl# 4</b>  <b>Accessible Entrance</b>  <b>Examples of Best Practises</b></p>

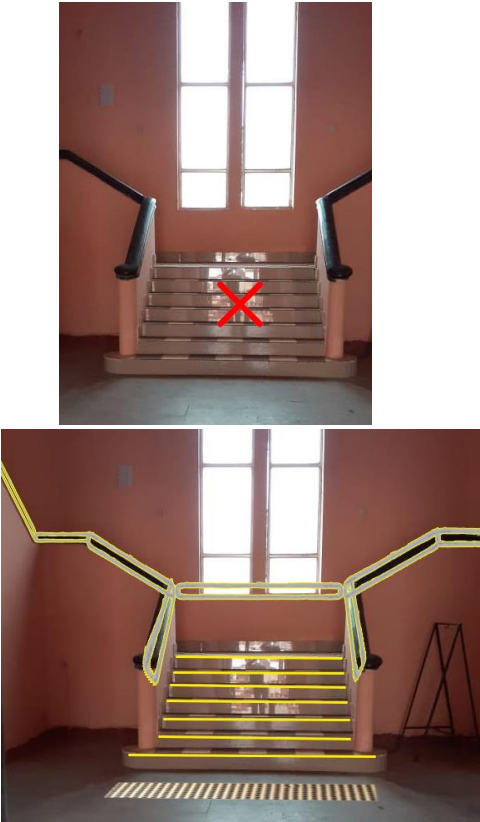
## 7. Handrail

Issues Observed	Photograph	Recommendation	Technical Recommendation
<p>1. Both side inaccessible concrete Handrail</p>

<ol style="list-style-type: none"> <li>1. Handrails to be installed at both sides with two grip heights of 900mm and 760mm.</li> <li>2. Handrails to be circular have smooth surface and are non-slippery.</li> <li>3. Adequate hand clearance between the wall and the handrail of 50 mm or more.</li> <li>4. Handrails to be maintained and kept free from dust.</li> </ol>	<p><b>Sl# 8 Handrails</b> Examples of Best Practises</p>

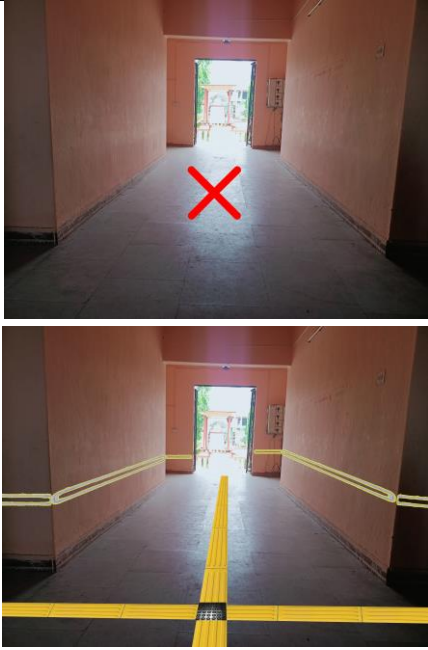
## 8. Corridor

Issues Observed	Photograph	Recommendation	Technical Recommendation
<ol style="list-style-type: none"> <li>1. Building corridor width is more than 3048 mm.</li> <li>2. 1500 mm x1500mm space for wheelchair 360° turn.</li> <li>3. No grip bar on wall. No guiding tiles.</li> <li>4. Floor finish Non slippery</li> <li>5. Good Colour Contrast.</li> <li>6. Corridor obstructed by chairs.</li> <li>7. Notice board height is 1600 mm.</li> <li>8. Good illumination</li> </ol>

<ol style="list-style-type: none"> <li>1. Grab bars on both sides of the corridor.</li> <li>2. Protruding objects to be removed or re-arranged.</li> <li>3. Notice board should establish in the height of 900mm.</li> <li>4. Obstacles to be removed.</li> </ol>	<p><b>SI# 12</b> <b>Door and Doorways</b> <b>Examples of Best Practises</b></p>

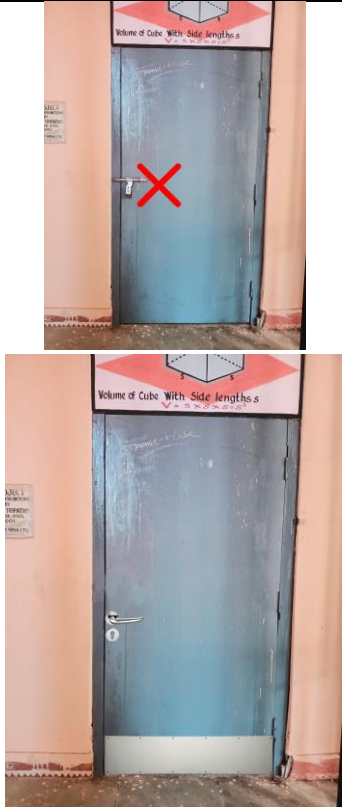
## 9. Door & Doorway

Issues Observed	Photograph	Recommendation	Technical Recommendation
<ol style="list-style-type: none"> <li>1. Easily opened.</li> <li>2. Door lock at 950 mm.</li> <li>3. No color contrast between door and wall.</li> <li>4. Door width 926 mm and easily opened.</li> <li>5. Handles at 950 mm from floor.</li> <li>6. Door lock at 950 mm from floor.</li> <li>7. No kick plate on the door.</li> </ol>

<ol style="list-style-type: none"> <li>5. Suggested color contrast between door, door frame, wall and floor – blue-white, blue-yellow, red-white the accessible toilet door</li> <li>6. Thresholds and doormats to be removed.</li> </ol>	<p><b>SI# 12</b>  <b>Door and Doorways</b>  <b>Examples of Best Practises</b></p>

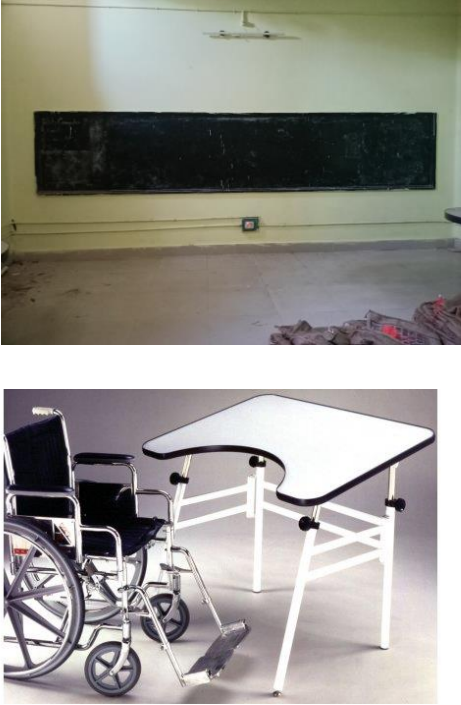
## 10. Classrooms

Issues Observed	Photograph	Recommendation	Technical Recommendation
<ol style="list-style-type: none"> <li>1. Inaccessible furniture.</li> <li>2. Accessible blackboard in classrooms.</li> <li>3. Blackboard height 640 mm</li> </ol>

<ol style="list-style-type: none"> <li>1. 900 mm height, 900mm wide and 1200mm deep clear space in front of the book issue counter</li> <li>2. should have adequate space for the wheelchair of 1500mm in the reading room.</li> <li>3. There should be a gap of 1200mm between bookshelves.</li> <li>4. Jaw's software to be install in at list 5 computers.</li> <li>5. There should be audio books and braille books.</li> <li>6. Black board height should be in 900 mm to 1200 mm.</li> <li>7. There should be proper illumination of 250 lux in classroom.</li> <li>8. There should be 1200 mm space to move the wheelchair in the classroom.</li> <li>9. Teacher should be trained to teach student with disability.</li> </ol>	<p data-bbox="1727 331 1995 411"><b>Sl# 14</b> <b>Cafeteria</b> <b>Examples of Best Practises</b></p>

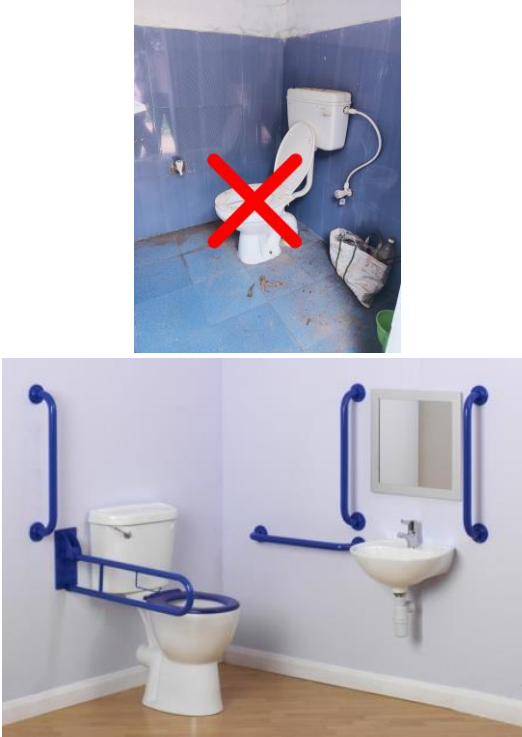
## 11. Accessible Toilet

Issues Observed	Photograph	Recommendation	Technical Recommendation
<ol style="list-style-type: none"> <li>1. Pathway towards toilet inaccessible.</li> <li>2. 30 toilets in school</li> <li>3. Toilet door width is 923mm.</li> <li>4. 10 toilet has Indian commode style pan.</li> <li>5. No lighting.</li> <li>6. There is a color contrast between the floor, wall, and sanitary fittings.</li> <li>7. No water.</li> <li>8. Inaccessible Ramp Available in front of toilet</li> <li>9. Cubicle size is 1524x 1828mm.</li> <li>10. Basin height 792 mm, Depth 304mm</li> <li>11. No colour contrast</li> <li>12. Bad illumination.</li> <li>13. No grab bars.</li> <li>14. No Signage</li> </ol>

<ol style="list-style-type: none"> <li>1. Toilet door to open outwards, be double hinged or sliding type.</li> <li>2. WC to be installed in a corner with centre line of the WC at a distance of 450mm to 500mm from the adjacent wall. The front edge of WC to project 750mm of/from the rear wall.</li> <li>3. Seat height 450mm.</li> <li>4. Horizontal grab bar to be installed on adjacent wall at a height of 200mm from the WC seat.</li> <li>5. A fold up grab bar to be installed at a centreline distance of 320mm-200mm from the WC seat.</li> <li>6. Wash basin to be installed at a distance of at least 400mm from the side wall.</li> <li>7. Top-edge of the wash basin at a height between 800mm and 840mm from the floor level.</li> <li>8. Clear knee space of at least 750mm height x 750mm width x 200mm depth under the</li> </ol>	<p data-bbox="1727 472 1995 547"><b>SI# 13</b> <b>Accessible Toilet</b> <b>Examples of Best Practises</b></p>

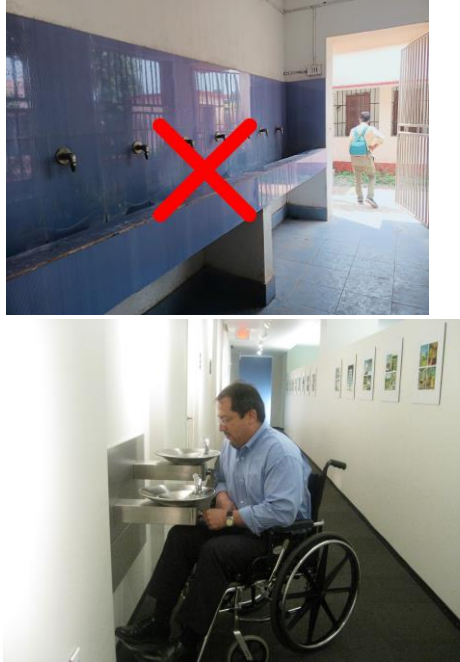
## 12. Drinking Water

Issues Observed	Photograph	Recommendation	Technical Recommendation
<ol style="list-style-type: none"> <li>1. Approach to drinking water not accessible.</li> <li>2. Wash basin height 643mm</li> <li>3. Two Staircase Available Height 307 mm</li> <li>4. Classroom to Drinking water point Inaccessible.</li> <li>5. One Drinking Water point Available</li> </ol>

<ol style="list-style-type: none"> <li>1. To be Establish a water filter</li> <li>2. Height of water filters to be lowered (not higher than 1200 mm).</li> <li>3. Clear knee space of at least 750mm height x 750mm width x 200mm depth under the wash basin, with additional toe-space of 300mm height x 750mm width x 230mm depth</li> <li>4. Drinking glass and cups required.</li> </ol>	<p><b>SI# 15</b> <b>Drinking Water Facility</b> Examples of Best Practises</p>

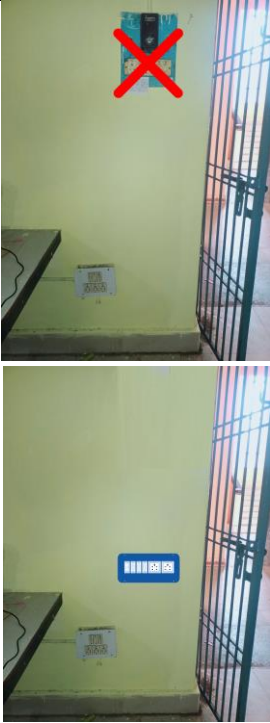
### 13. Control and Operating Mechanism

Issues Observed	Photograph	Recommendation	Technical Recommendation
<p>1. Switch board height 1252 mm.</p> <p>2. No colour contrast between switch board and wall.</p>

<p>1. Switch board to be reinstalled at height of 900 - 1200mm and not below 400mm. Clear space from the corner of 400mm.</p> <p>2. Information on controls and switches in Braille.</p>	<p><b>SI# 16</b>  <b>Control and Operating Mechanisms</b>  <b>Examples of Best Practises</b></p>

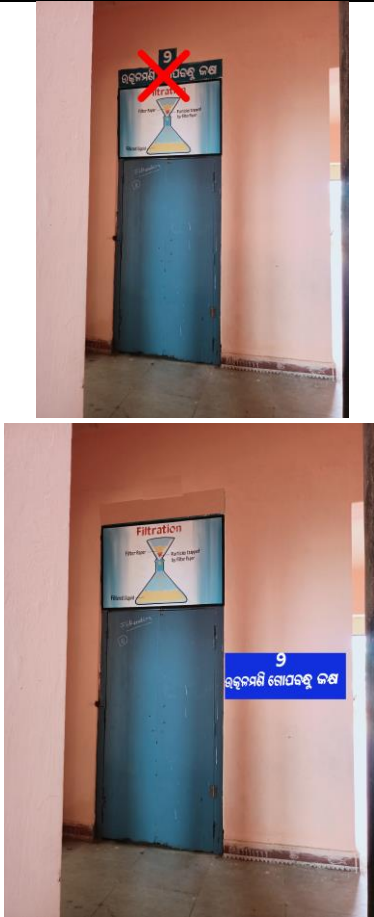
## 14. Signage

Issues Observed	Photographs	Recommendation	Technical Recommendation
<p>1. Inaccessible Signage Available</p> <p>2. Signage Height 3657mm</p>

<p>1. Prominent visible signage using the international symbol of accessibility, identifying/advertising/ signifying accessible entrance and exit, reserved car parking, presence of toilets for persons with disabilities and availability of special services.</p> <p>2. Signage size not less than 60 mm for doors, 110 mm for corridors and 200 mm for external use.</p> <p>In the facility to be provided with Braille and Tactile supplements.</p> <p>1. Wherever possible, audio signage to be provided along with Braille and Tactile.</p> <p>2. All Braille and tactile signage to be placed at the height of 900-1500mm, with ideal location at 1050 mm above the finished floor level.</p> <p>3. Signage to be placed/mounted on the wall alongside the door.</p>	<p><b>SI# 17 Signage</b> Examples of Best Practises</p>

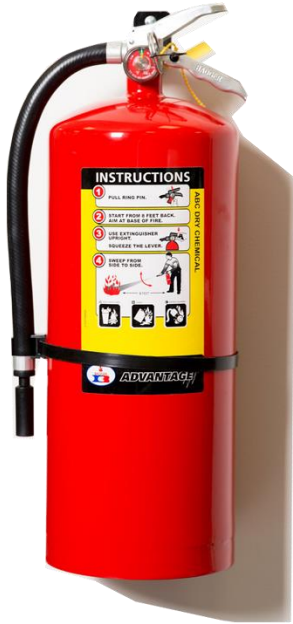
**15. Emergency Related**

Issues Observed	Photographs	Recommendation	Technical Recommendation
<ol style="list-style-type: none"> <li>1. No exit door.</li> <li>2. No emergency evacuation provision.</li> <li>3. No fire Extinguishers in school.</li> </ol>

<ol style="list-style-type: none"> <li>1. Evacuation route plan to be developed and displayed in different locations of each floor and</li> <li>2. From safety point of view classrooms of students / teachers with disabilities at ground floor. Classrooms to be made mobile so that as the child with disability would progress from one class to the other, that classroom would-be run-in ground floor.</li> <li>3. Staff to be trained to assist persons with disabilities during evacuation.</li> <li>4. Install fire extinguisher in every floor.</li> </ol>	<p><b>SI# 18</b>  <b>Emergency Evacuation</b>  <b>Examples of Best Practises</b></p>
